ASBESTOS MATERIALS REVIEW

MOTEL PRINCES HIGHWAY VICTORIA

February 2017

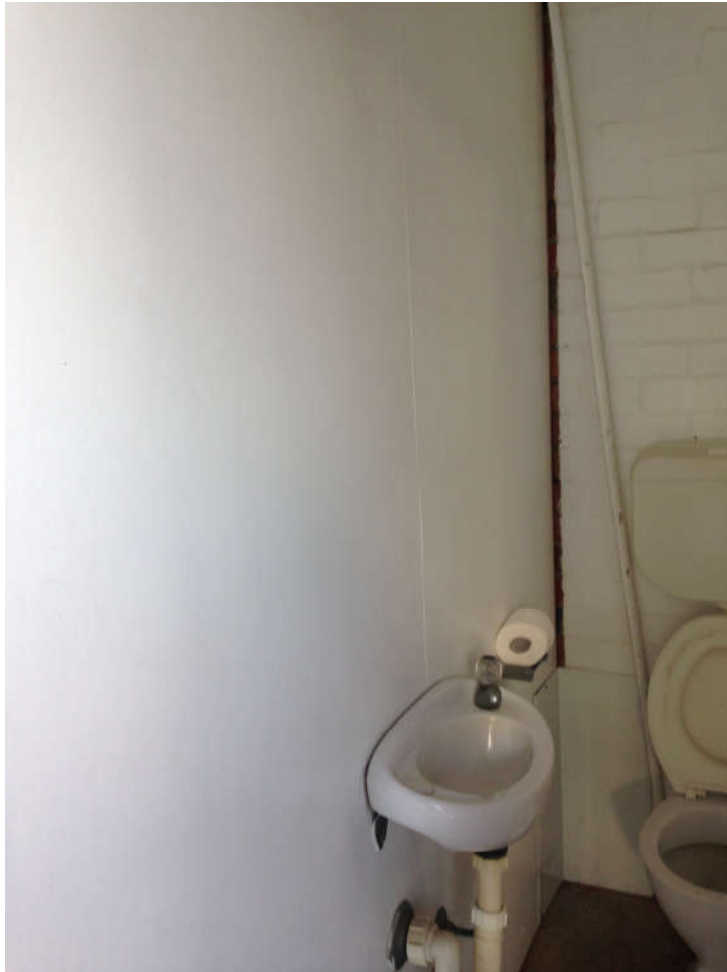
Staff toilet asbestos wall lining

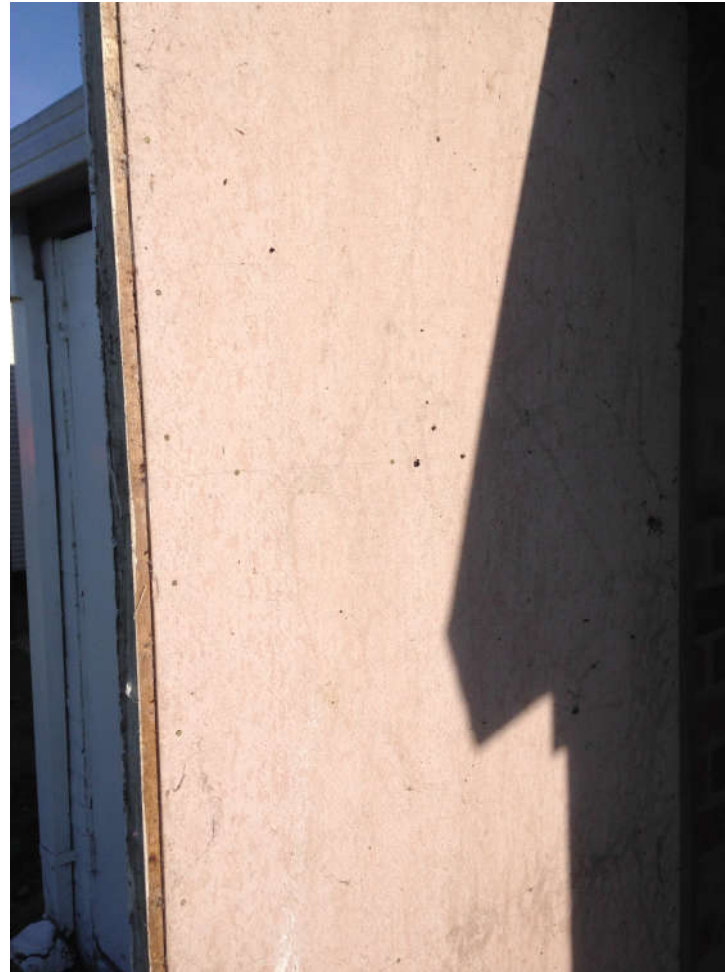
Storage room eastern end door lining asbestos cement sheet

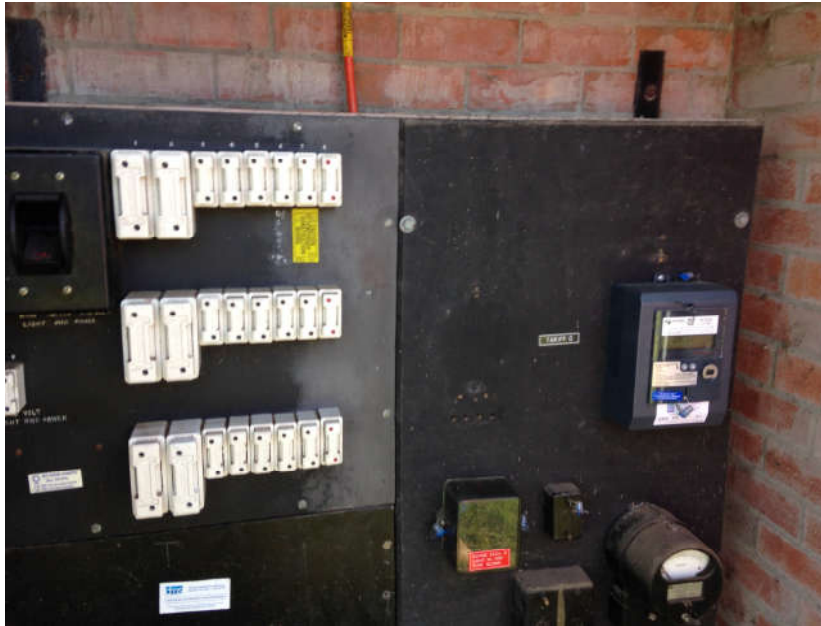
Zelemite asbestos electrical backing boards
NOTE: Fuses may contain asbestos

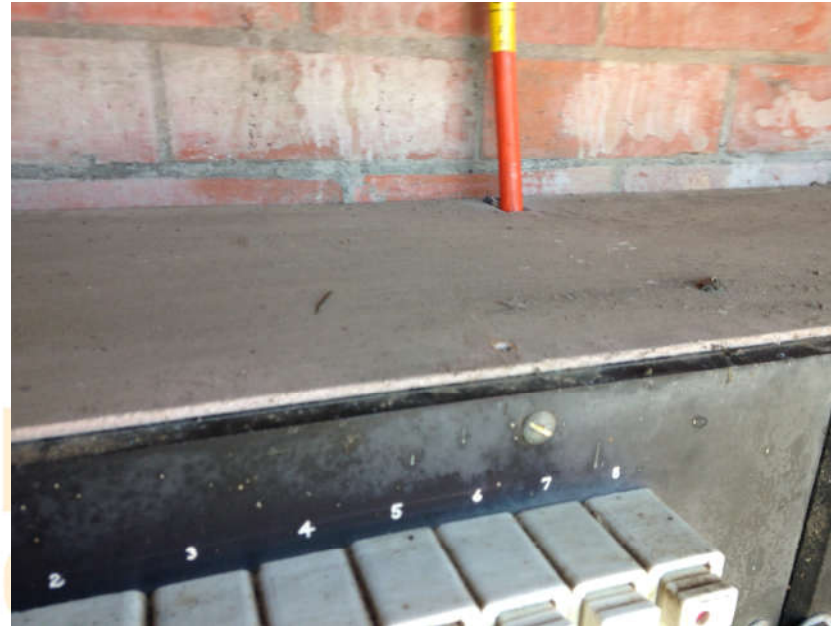
Asbestos cement sheet lining electrical backing boards

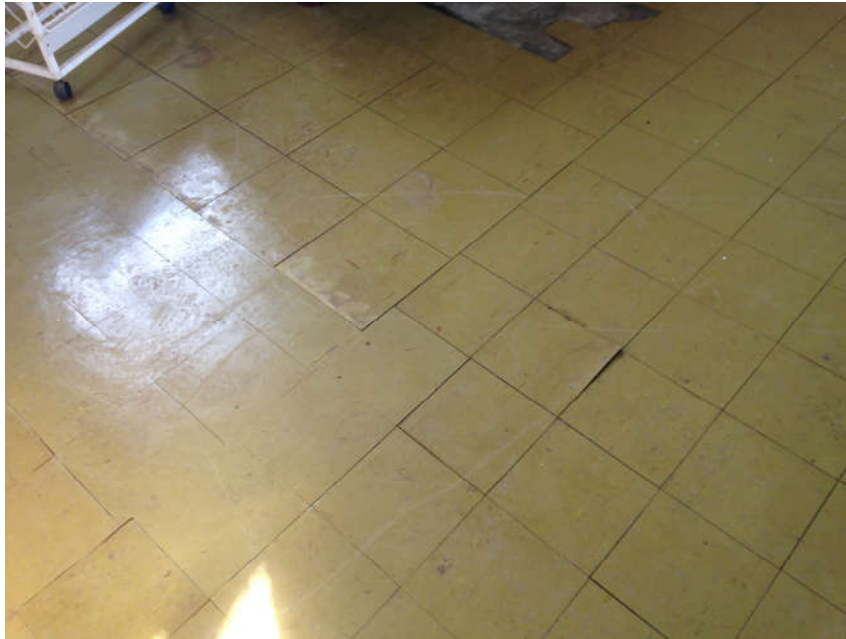
Asbestos vinyl tiles kitchen
REMOVED 2017

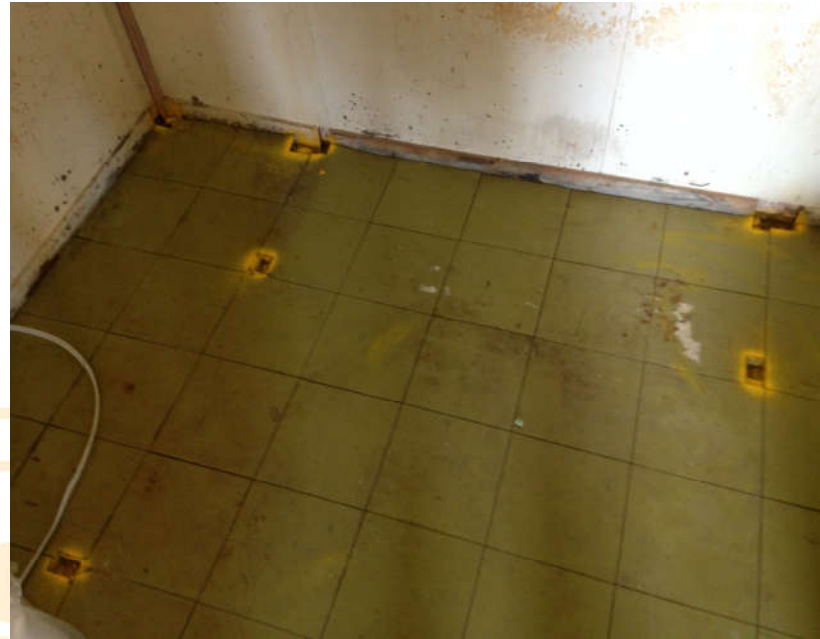
Asbestos vinyl tiles kitchen store penetrations sealed with paint
REMOVED 2017

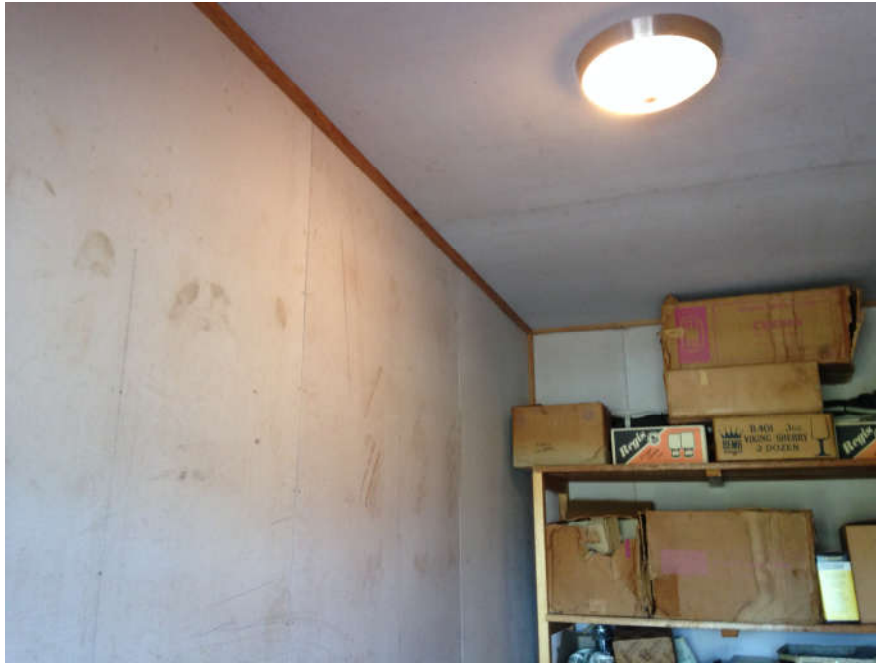
Store room western end unpainted asbestos sheeting

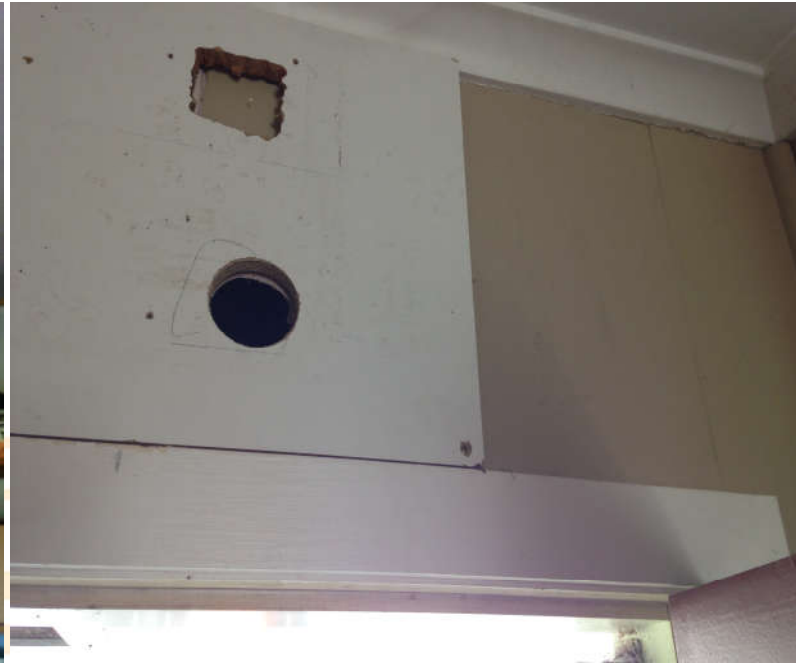
Motel unit #14 with air conditioner removed exposing asbestos sheet

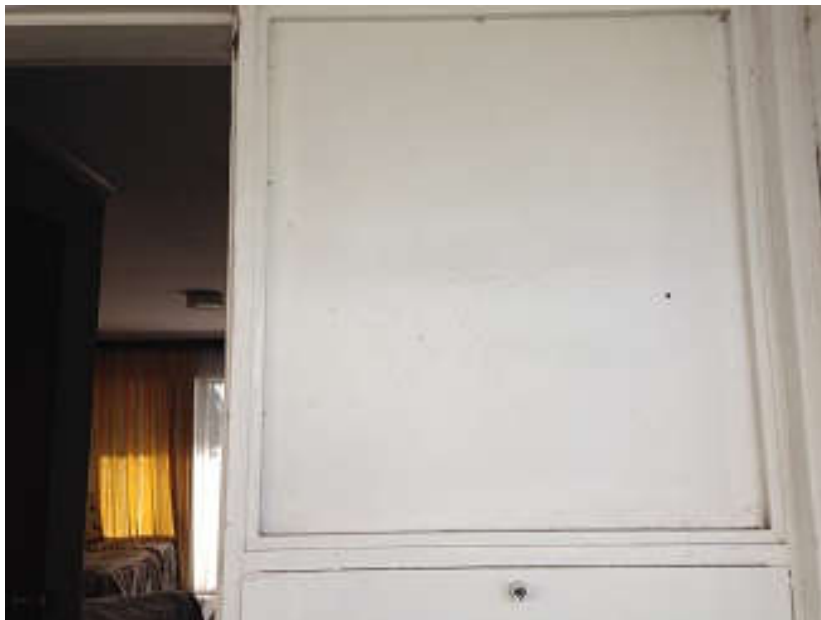
Wall infills above Motel unit server openings – asbestos cement sheet
TO BE REMOVED

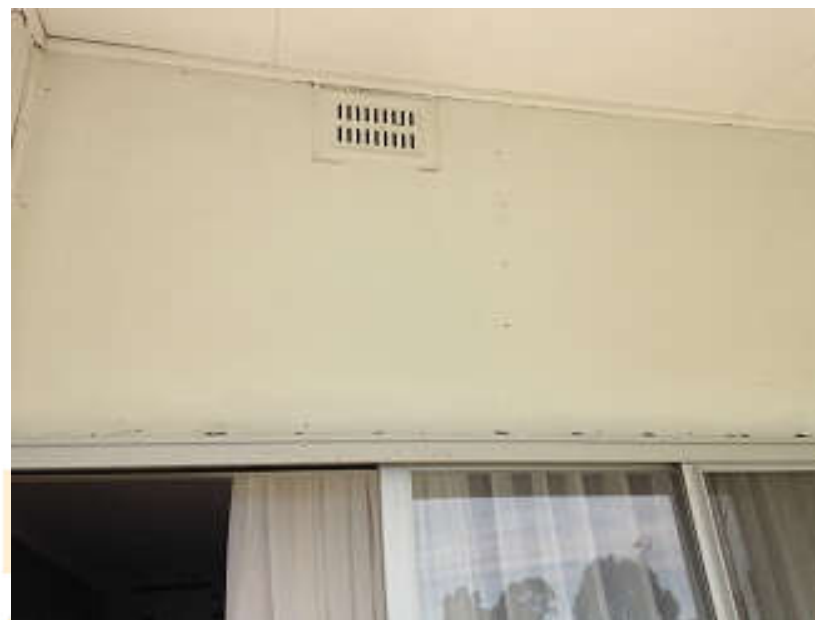
Wall infills above north windows all units – asbestos cement sheet
TO BE REMOVED
